Sub Regional RTEP Committee PJM West

May 21, 2018

Baseline Reliability and Supplemental Projects

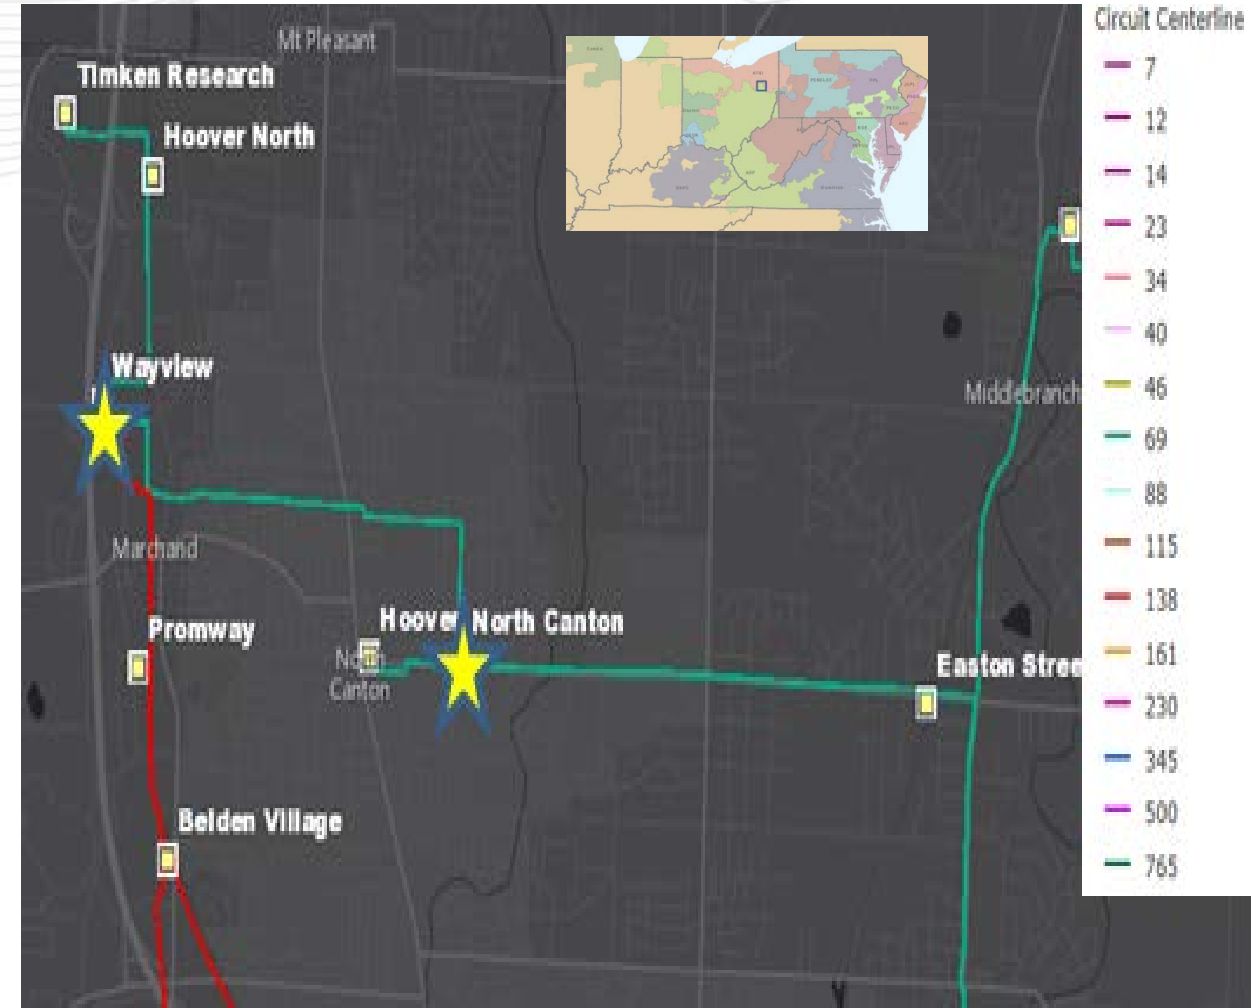
The North Canton 69-12kV distribution transformer failed. 69kV breakers E & G are oil-filled breakers made in 1963 (CF-48 model). The 69kV CB's E and G at North Canton are oil breakers without oil containment. Oil breaker maintenance has become more difficult due to the oil handling required to maintain them. Oil spills are frequent with breaker failures and routine maintenance, and can become an environmental hazard. These breakers are also models that are worthy of replacement due to their past reliability, and lack of spare part availability. These breakers have exceeded the designed number of full fault operations (10) with 12 and 26 fault operations respectively.

The 69kV circuit protection uses electromechanical relays and pilot wire, which is more prone to misoperations and has issues in finding repair parts. The 69kV protection will be upgraded to microprocessor relays and fiber-optic communications. The 69kV bus protection currently utilizes an older IAC electromechanical scheme, which needs upgraded to modern bus-differential protection. The RTU is also of an obsolete vintage and needs to be replaced.

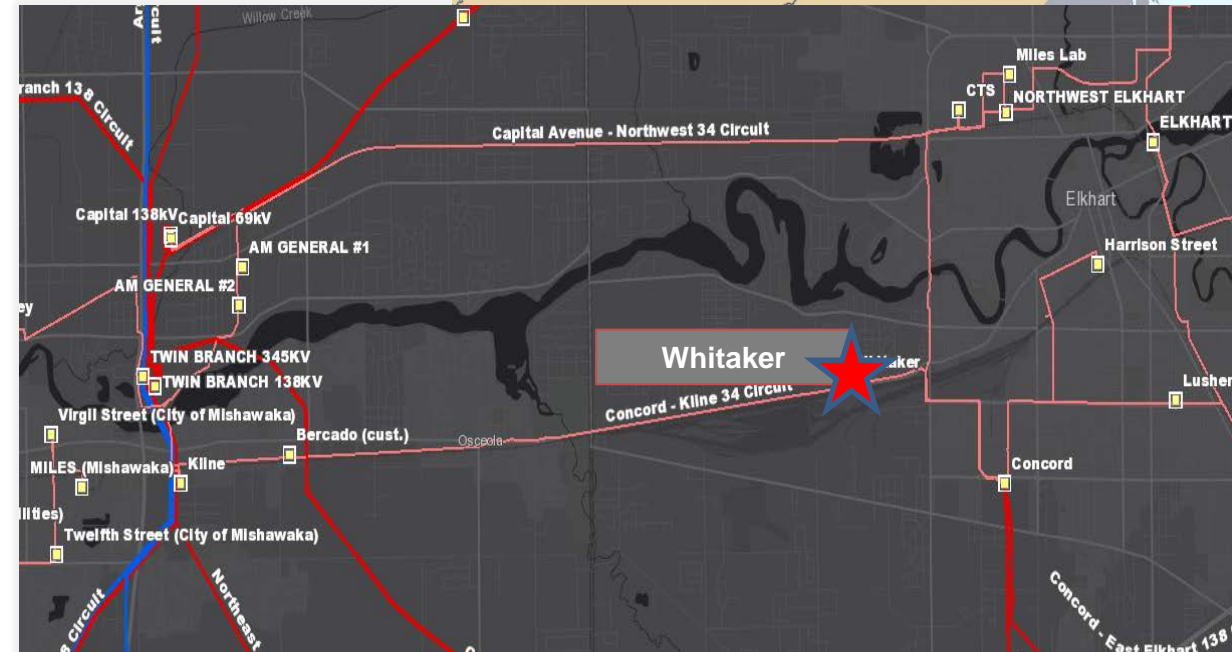
The 34.5/12kV Transformer #2 at Whitaker Station, manufactured in 1973, is showing signs of deterioration. The unit has extremely high values of combustible gasses and carbon dioxide. The unit has experienced overheating temperature faults. Also, the interfacial tension is extremely low proving that the oil is in poor condition. The LTC DGA values are high for Ethylene and the LTC compartment shows visible leaks. Drivers for replacement of the transformer include breakdown in dielectric strength (insulation system), short circuit strength (winding short circuit strength breakdown due to magnitude of short circuit fault events), oil quality issues and accessory problems (bushings, pumps etc.).

The 12kV Circuit Breakers A and B manufactured in 1968 are oil filled breakers without oil containments. Oil filled breaker maintenance has become more difficult due to the oil handling required to maintain them. Oil spills are frequent with breaker failures and routine maintenance and can become an environmental hazard. Breaker A has had 221 fault operations and breaker B has had 84 fault operations. The manufacturer recommendation is 10 for this type of breaker. The Breakers have numerous issues related to age, wear, PCB content, maintenance issues and no repair part availability.

Adding the Bus Tie Circuit breaker will keep the distribution customer energized when we lose one of the two lines serving this station.
