Sub Regional RTEP Committee Western Region AEP

January 11, 2019

Needs

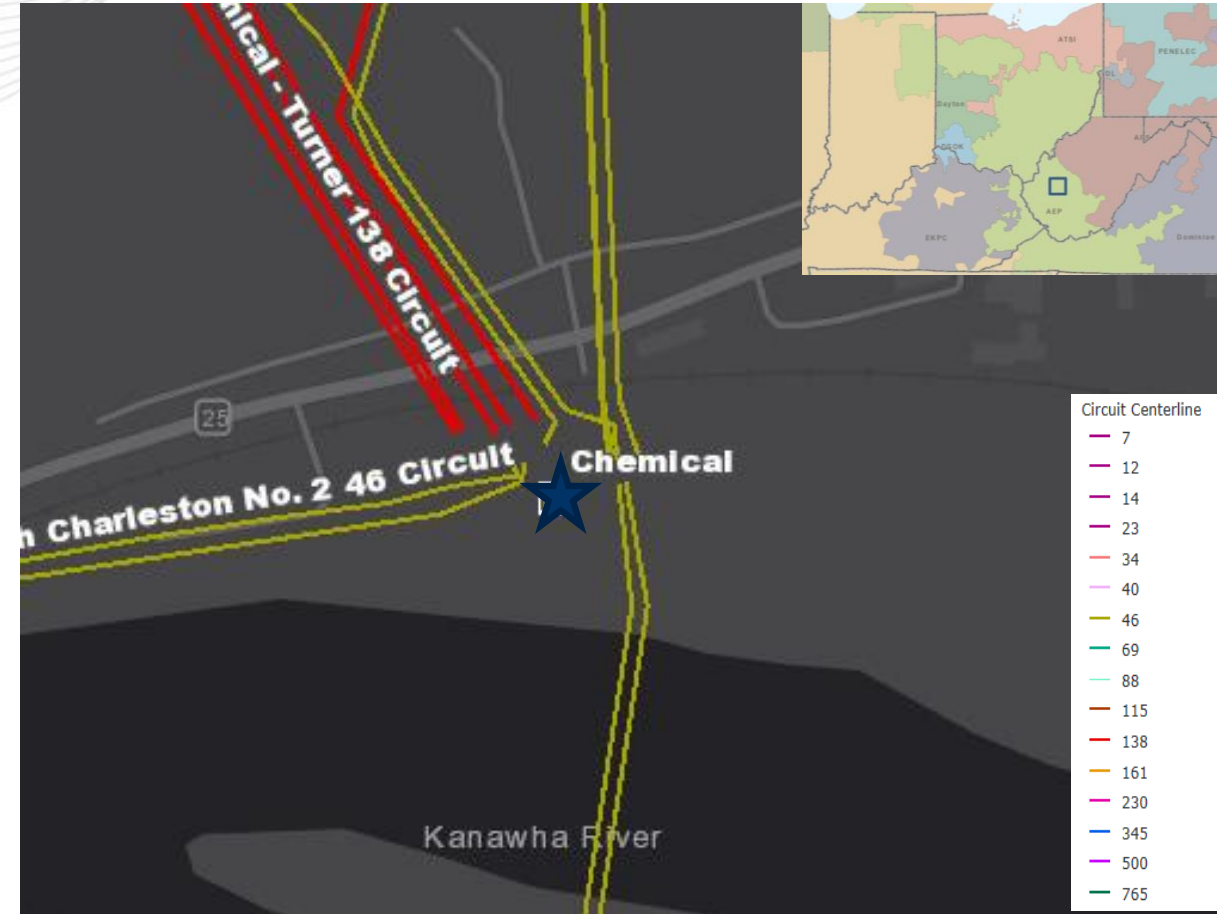
Need Number: AEP-2018-AP018

Chemical 138/46 kV XF #1 has been declared a failure. Operations has noted that Chemical 138/46 kV XF #1 fans and cooling system are not working properly and winding temperature was documented at an extremely hot level of 109°C prior to taking the unit offline in 2017. There are no parts attainable to repair the obsolete cooling system. In addition, interfacial tension has been diminished since 2002. This is an early indication of the development of sludge which can impede oil circulation, further hampering the ability of the unit to cool. Based on dissolved gas analysis, the observed gas concentrations, specifically of ethylene and acetylene, are likely the result of a mixture of thermal and electrical faults along with the carbonization of the insulating paper. The signal of insulation paper carbonization, which generates particles in the oil, highly correlates to the generation of sludge indicated by the interfacial tension.

Chemical 138/46 kV XF #2 moisture levels have recently been increasing, resulting in downward trending dielectric strength. In addition, interfacial tension has been on the decline. This is an early indication of the development of sludge which can impede oil circulation and cooling. Operations has noted numerous conditions with this unit, most critical of which is that the bank was derated to 33.75MVA because only one pump of three is operational for the cooling system. There are no parts attainable to repair the obsolete cooling system.

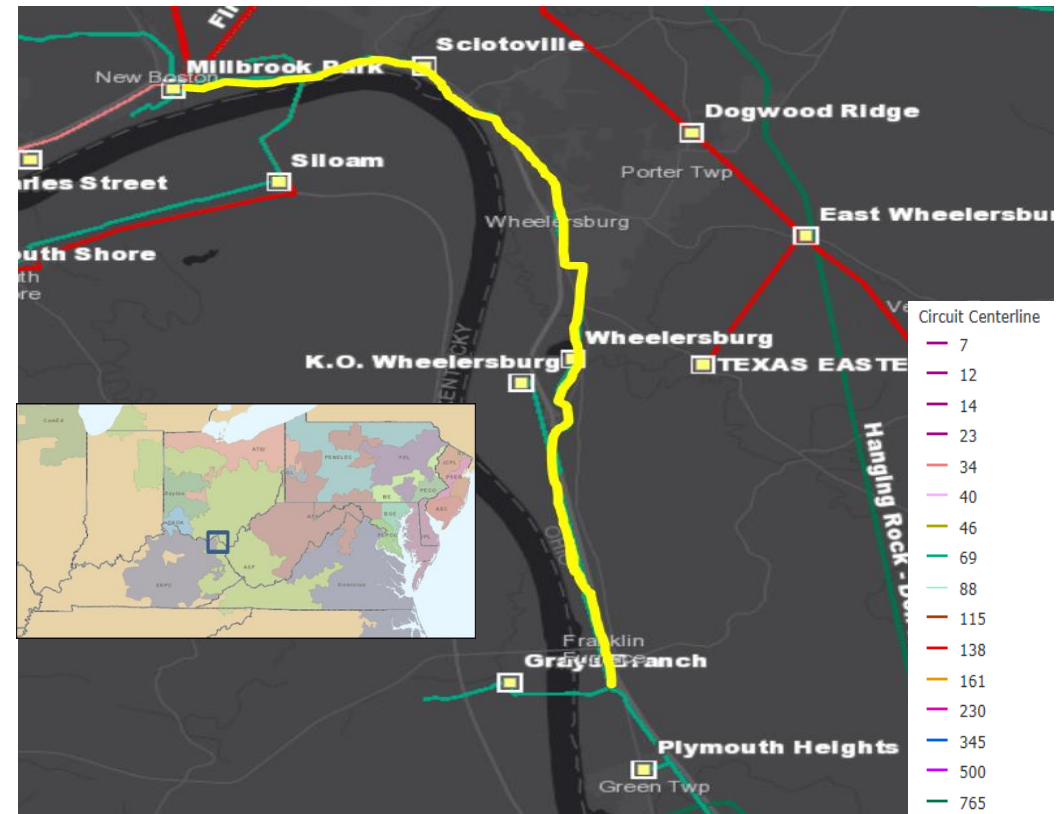
Need Number: AEP-2018- OH030

- The 27-mile 69kV Portsmouth-Ironton line (vintage 1915) uses wood pole structures with variety of conductors, mostly 2/0 Cu (40 MVA rating). A 11.9 mile section between Millbrook Park and Franklin Furnace has 73 open A conditions, including rotten cross-arms, burnt/broken insulators, and loose/broken conductor hardware.

- The Millbrook Park-Franklin Furnace-Argentum line is a 3-terminal line. Three-terminal lines cannot be adequately protected due to the complexity of coordination, which, causes misoperations including over-tripping. The Millbrook Park-North Haverhill-Argentum circuit is protected by an impedance based Directional Comparison Blocking (DCB) pilot system, which cannot adequately protect a three terminal lines.

- The Texas Eastern Substation serves a peak load of 26 MW via a 2.1-mile radial line from East Wheelersburg. Also, K.O. Wheelersburg is a 1.2 MVA 69 kV retail load served off a 1.3-mile radial line. These radial loads are at risk of extended outages for line maintenance or repair.

- At Sciotoville, CBs A and B are both oil type breakers with 16 and 10 fault operations respectively. This particular model has no spare parts and a history of poor reliability. Sciotoville has a ground switch MOAB on the transformer. Ground switch MOAB's cause intentional high side faults to clear the transformer faults which cause damage to and reduction in life of nearby equipment.

- Sciotoville and Wheelersburg currently have 8 (of 10) and 10 (of 10) electro-mechanical relays respectively. EM relays have no spare part availability, a lack vendor support, no SCADA functionality, and no fault data collection ability.

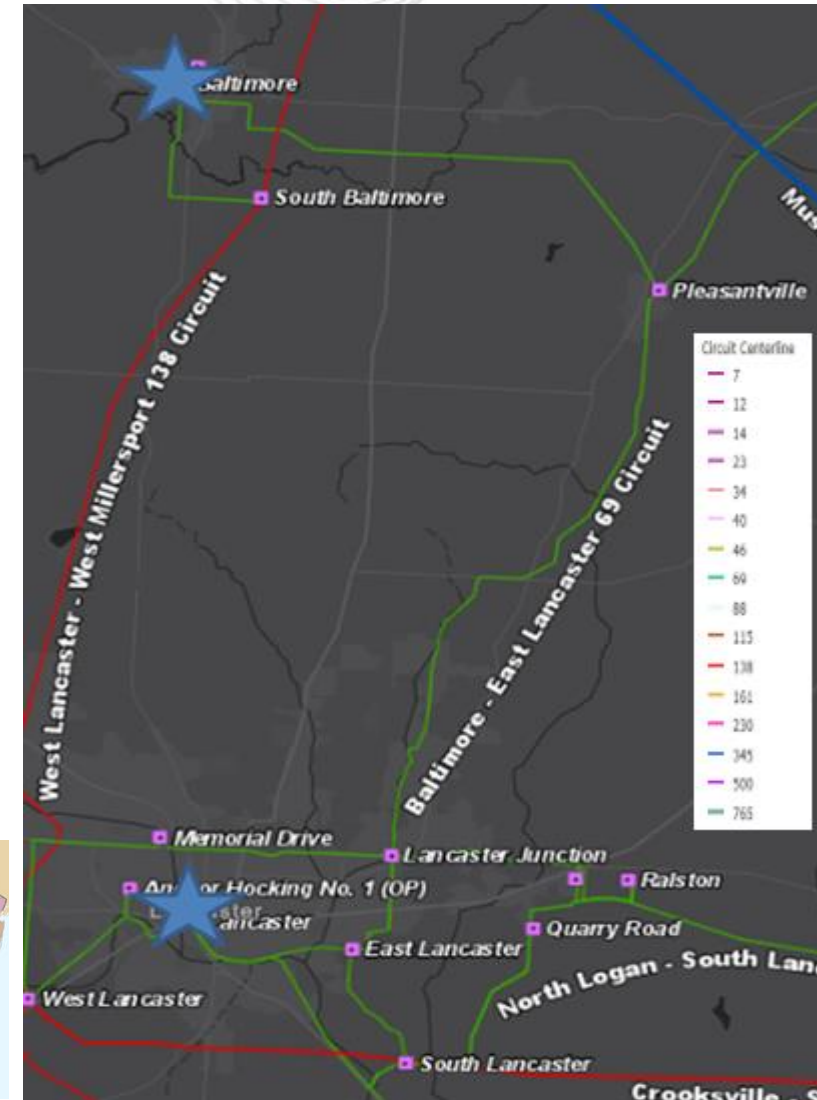
- Baltimore 69kV CBs E and F are oil type breakers (vintage 1951) and have been identified for replacement due to lack of spare part availability, historical reliability, and lack of vendor support. Oil breakers are difficult to maintain due to oil handling requirements. Oil spills can occur during maintenance and fixes. The breakers have experienced the following fault operations: CB E (5), CB F (5).

- Lancaster 69kV CBs B and D are oil type breakers (vintage 1989) and have been identified for replacement due to lack of spare part availability, historical reliability, and lack of vendor support. Oil breakers are difficult to maintain due to oil handling requirements. Oil spills can occur during maintenance and fixes. The breakers have experienced the following fault operations: CB B (4), CB D (18).

- Lancaster currently has 46 electro-mechanical relays employed. EM relays have limited vendor support, lack of SCADA functionality, and don't offer fault data collection

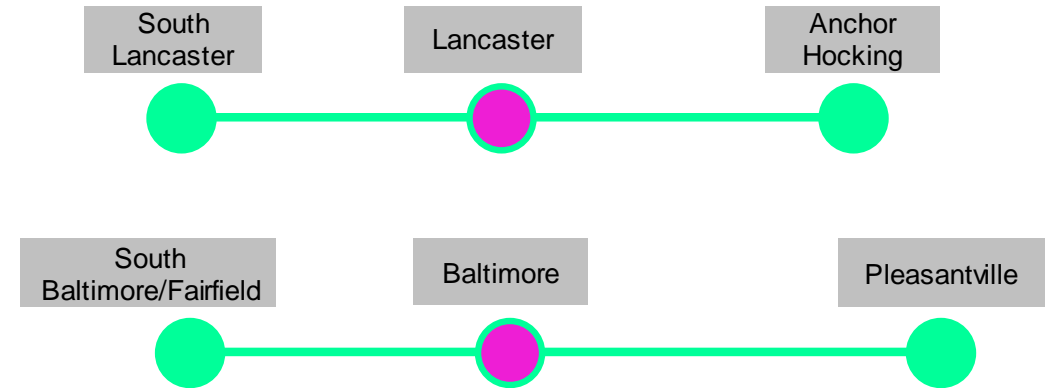
At Lancaster station, replace existing 69 kV CB B and CB D with new non-oil breakers and upgrade relaying at the station. Estimated cost: \$3.02M

At Baltimore station, replace existing CBs E and F with new non-oil breakers and upgrade relaying at station. Estimated cost: \$2.21M
