Sub Regional RTEP Committee: Western AEP Supplemental Projects

October 16, 2020

AEP Transmission Zone M-3 Process Parsons 138kV Conversion

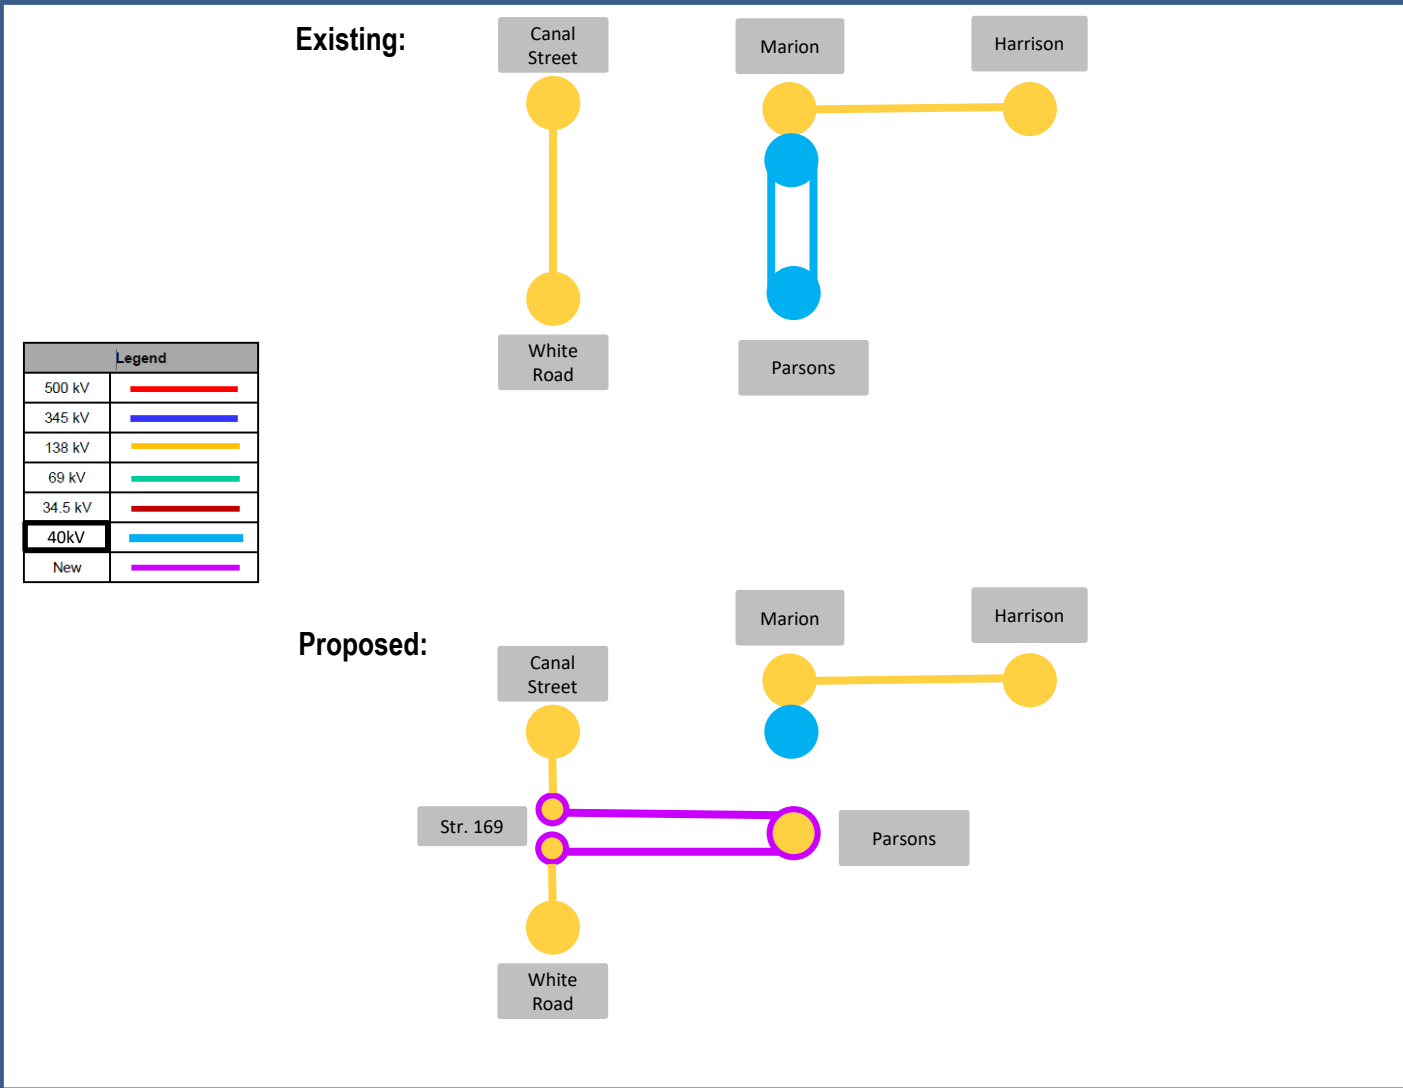
- Marion – Parsons 40kV: Retire ~5.2 miles of double circuit 40kV line between Marion and Parsons. **(\$2342.1) Cost: \$2.97M**
- Parsons 138kV Extension: Extend the Canal Street – White Road 138kV circuit to Parsons ~2.0 miles of double circuit 138kV line (Greenfield) using 795 ACSS conductor. Extend fiber cable & install redundant fiber cable for relaying and communication to Parsons Station. **(\$2342.2) Cost: \$17.04M**
- Parsons 138kV Station: Replace existing 40kV yard with 138kV ring bus. Perform remote end work at Canal Street and White Road stations. **(\$2342.3) Cost: \$7.78M**
- Marion 138kV Station: Retire existing circuit breaker 21. **(\$2342.4) Cost: \$0.1M**

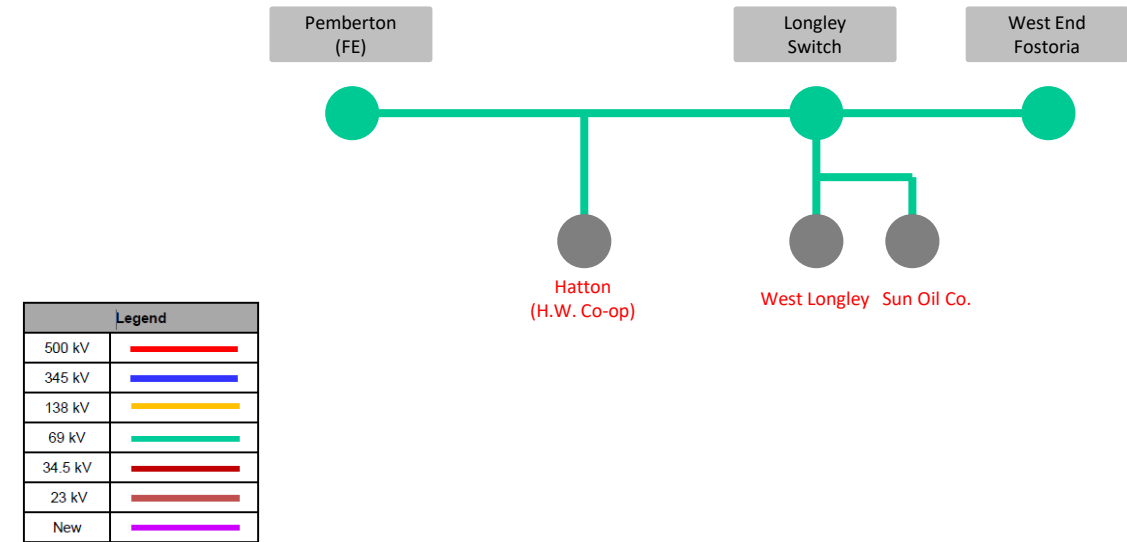
Existing Configuration:

- Hancock-wood Co-op's has requested for new service to replace their existing Hatton Delivery Point. Hatton delivery point is currently served via a hard tap from the Pemberville (FE) – West End Fostoria 69kV circuit. The new customer station is being built adjacent to their existing substation. The hard tap limits operational capabilities for this circuit. It is difficult to coordinate maintenance efforts because any work on the section from Longley Switch to Pemberville (FE) involves outage to the Hatton Delivery Point.
- Load is approximately 2.26 MVA
- CMI: There were no unplanned outages, but there were six scheduled and one monetary outages that affected the customer, in the last 5 years.

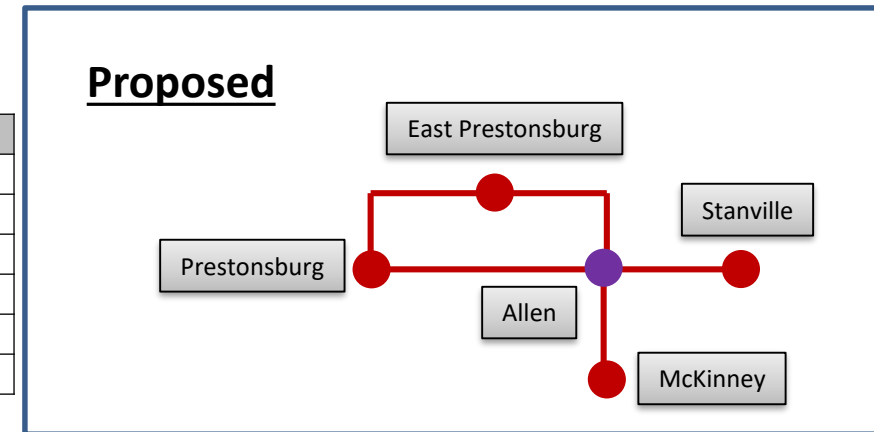
Stanville – Allen: A segment of this line will have to be relocated to the new station (SN/SE/WN/WE: 50/50/63/63MVA). **Estimated Cost: \$0.17 M**

Allen – Prestonsburg: 0.25 mile segment of this existing single circuit will be relocated. The relocated line segment will require construction of one custom self-supporting double circuit dead end structure and single circuit suspension structure. A short segment of new double circuit 69kV line (energized at 46 kV) will be added to tie into the new Allen Station bays which will carry Allen – Prestonsburg 46kV and Allen – East Prestonsburg 46kV lines. A temporary 0.15 mile section double circuit line will be constructed to keep Allen – Prestonsburg and Allen – East Prestonsburg 46kV lines energized during construction. **Estimated Cost: \$2.66 M**

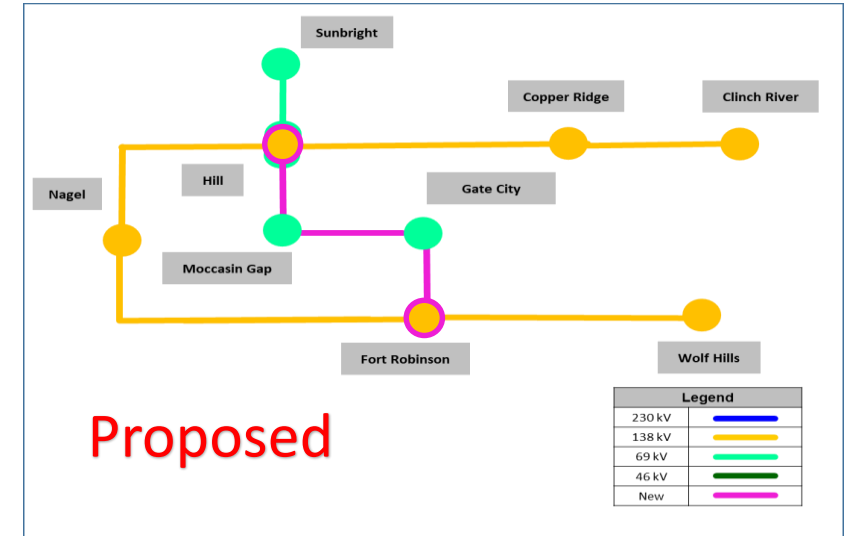
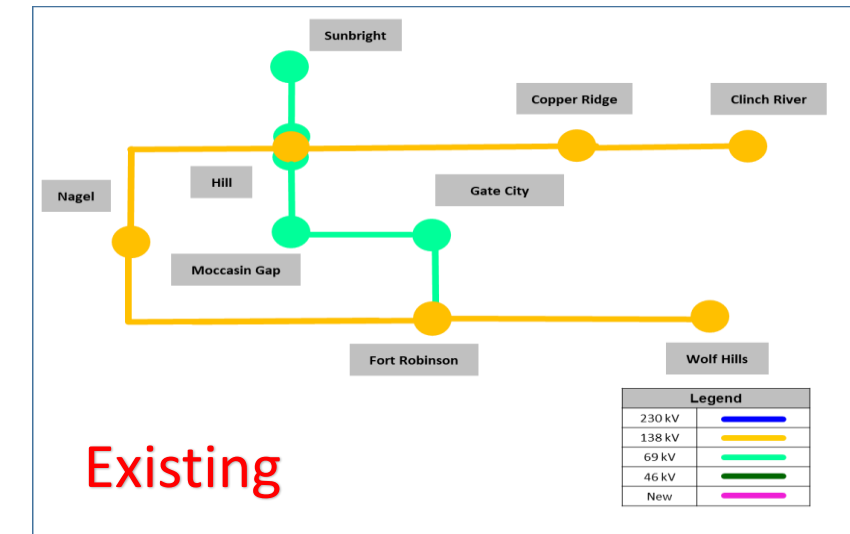
- At Fort Robinson station, replace existing 69 KV circuit breaker E with a new 3000A 40 KA circuit breaker. Replace existing 34.5 KV circuit breaker D with a new 69 KV rated 3000A 40 KA circuit breaker. Replace existing ground bank at transformer # 1 with new ground bank. Replace existing ground MOAB for transformer #1 with H.S. circuit switcher. Replace existing line MOABs Y & W with 138 kV circuit breakers. Replace 34.5 kV disconnects on breaker J. Install new low side 34.5 KV Circuit breaker at Transformer #1. **Estimated Cost: \$7.2M**

- At Hill station, replace existing 69 KV circuit breaker H with new 40 KA 3000A circuit breaker. Replace existing 69 KV circuit breaker E with new 40 KA 3000A circuit breaker for constructability flexibility, existing breaker E can be used as a capital spare. Replace existing 69 KV cap bank circuit switcher AA with new circuit breaker. Replace existing 138/69 KV 40 MVA transformer # 1 with new 138/69 KV 40 MVA transformer #1, add H.S. circuit switcher to the new transformer. Replace existing 138KV line MOABs W & Y with new 138 kV circuit breakers. Replace ground MOAB switches on 138/12 KV T2 with circuit switcher. **Estimated Cost: \$6.7M**
